Symphony Hills Homes Association

Pool Deck Project 2023

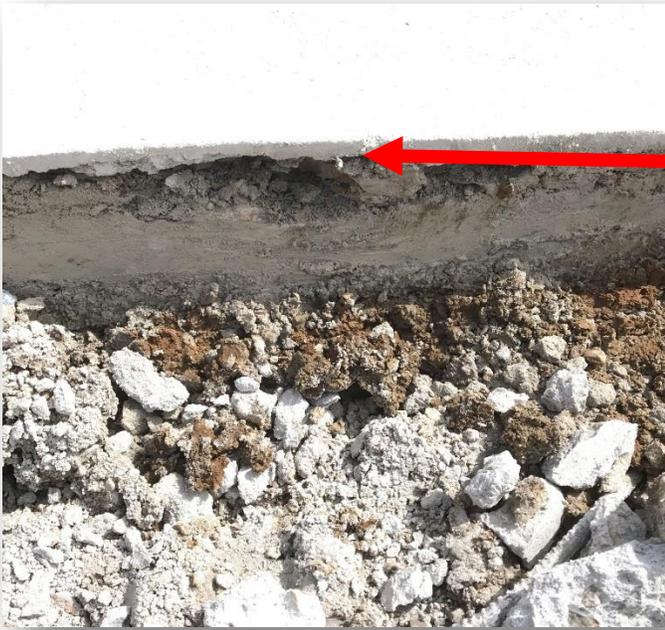
The Concrete has broken down over the past two decades and, in some areas, remaining was less than 1 inch thick, resulting in cracks and spalding

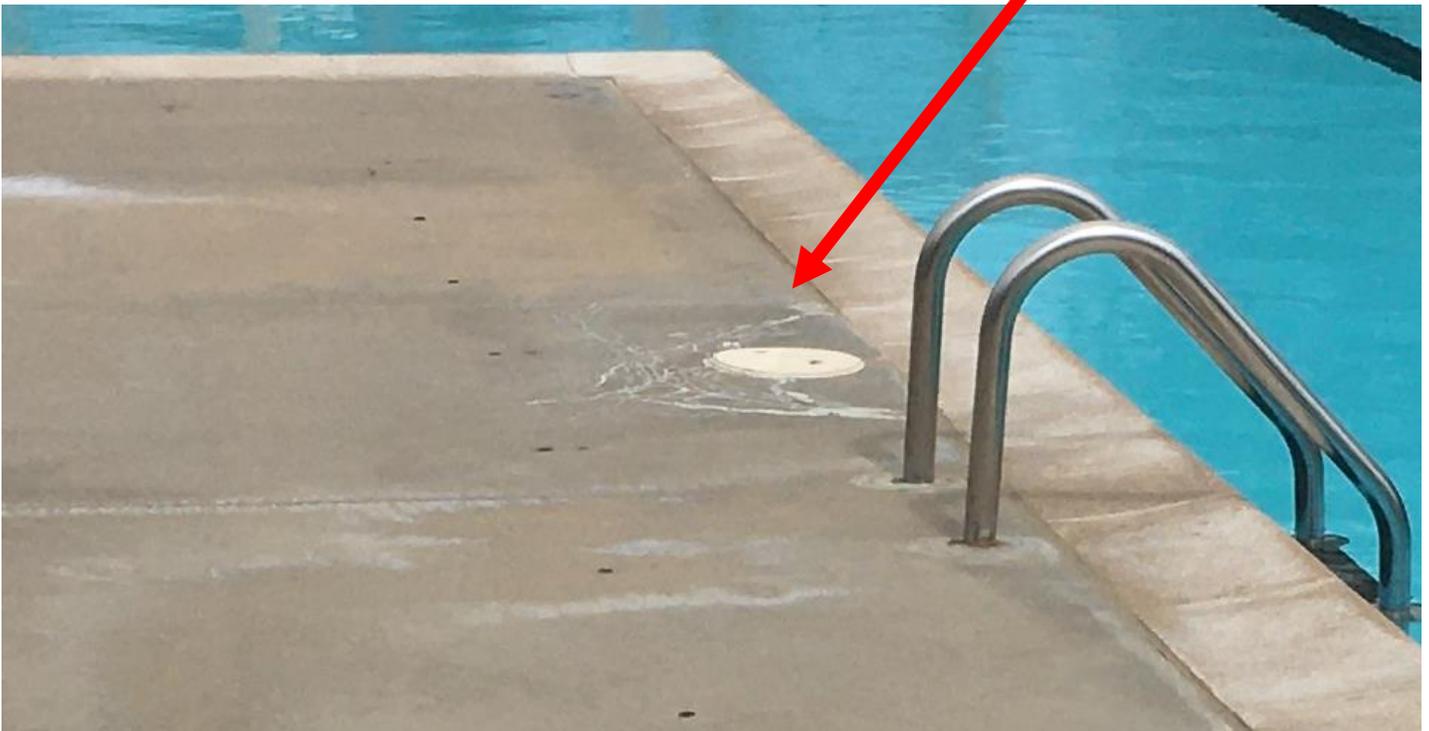
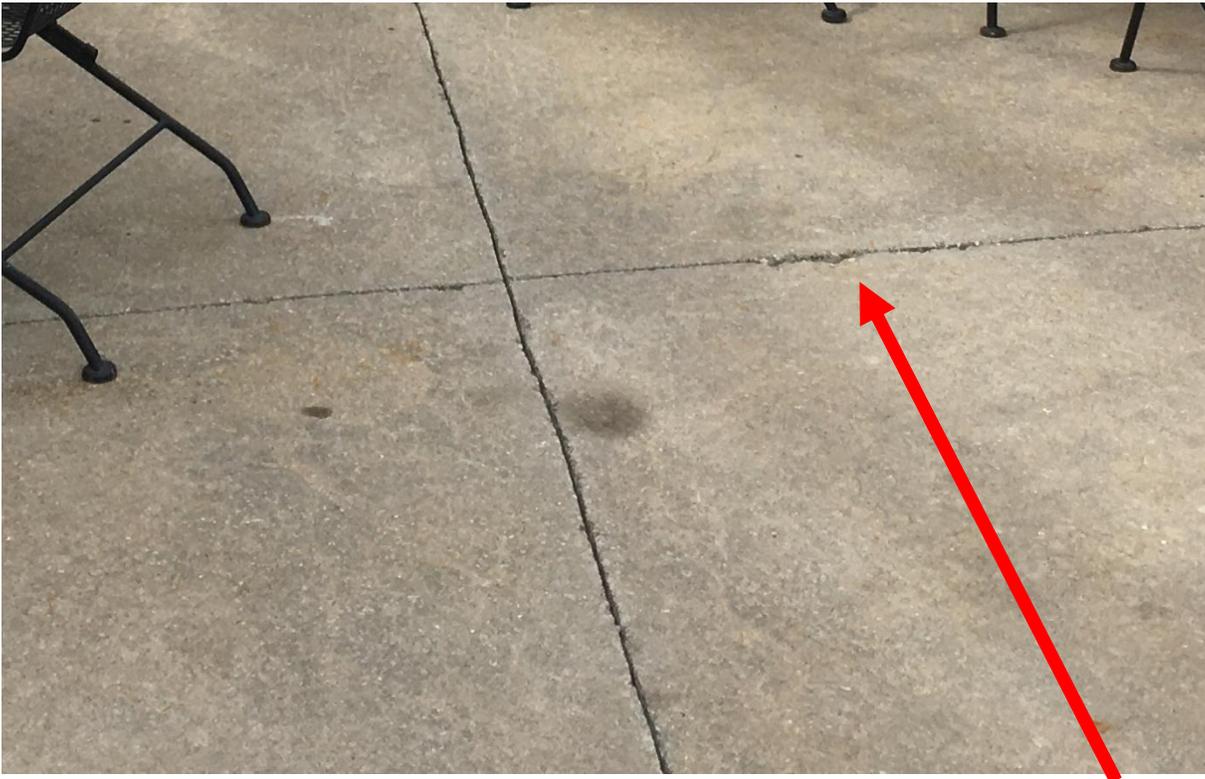
Parts of slabs crumbling and many small and medium cracks allowing water to cause further damage
